Replacement of main coils of RRC-W sector magnet

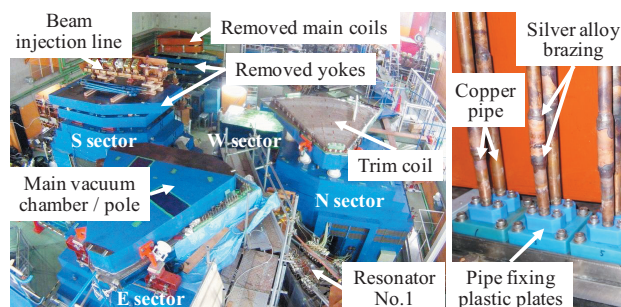
In the replacement task, three difficulties were anticipated, as shown in Fig. 1. The first one is how to deposit and store yokes, poles, the main vacuum chamber, and the beam injection line that was removed temporarily in the RRC room. Because of their heavy weight and large size, these removed parts were carried to and stored on the S, N, and E sector magnet, in addition to the south side of resonator No. 2, and in front of the shield door between the RRC room and the D room. The removed main coils were

carried out from the RRC room and stored in the IRC room. The second difficulty is that we have to loosen and tighten 13 bolts for fixing the vacuum chambers onto the magnetic pole surfaces. Since these bolts were in the deep and narrow vacuum chamber, we ran a test successfully by using an air drive tool having a long grip in advance in the winter of 2013. The last difficulty is the silver alloy brazing of copper pipes used for cooling water and electrification of trim coils. 116 pipes were cut to remove main vacuum chamber and poles, and parts of the cut pipes were newly fabricated and cleaned for a new silver alloy brazing. Because of the high number of copper pipes, it took a week to braze these pipes with a silver alloy. Furthermore, because several pipe fixing plastic plates were used for the fixation of pipes and maintaining vacuum, we had to frequently investigate the vacuum leak from the sub-vacuum chamber.

Fig. 1. Deposition and storage of removed parts and copper pipes of trim coil after silver alloy brazing.

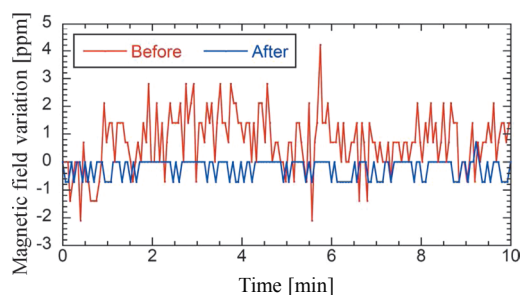
The present performance of the RRC-W sector magnet is greatly improved, as shown in Fig. 2. Though the magnetic field of the RRC-W sector magnet before the replacement had been fluctuating over a wide range of ± 5 ppm, at present, the RRC-W sector magnet has a stable magnetic field without a fluctuation.

Fig. 2. Fluctuation of magnetic field before and after the replacement of main coils.
