Maintenance of vacuum conditions of RILAC

Maintenances of vacuum condition in RILAC are described. There had been two big problems of vacuum conditions at RILAC. One was a vacuum leak at a cavity No. 5, the other was a leak of vacuum at a cavity A1. The cavity No. 5 had a vacuum leak, the pressure of its vacuum was higher than 1×10^{-4} Pa. As for a problem of cavity No. 5, it was difficult to handle it because of its heavy weight, large scale and complicated structure. As shown in Fig. 1, the cavity No. 5 has a large vacuum chamber of which the inner wall was used as an electrode called “outer conductor.” Inside of the outer conductor, there were several electrodes to accelerate an ion beam. Some of the acceleration electrodes were connected to a large cavity called “center conductor.” Junction area between the electrode and the center conductor was sealed using an O-ring. The opposite side of the wall of the center conductor opposite side of the wall was exposed to atmosphere. Flanges were sealed using O-rings. All O-rings of the vacuum-sealing flanges on the outer conductor were exchanged with new ones, however the pressure was not improved, higher than 1×10^{-4} Pa. We found a

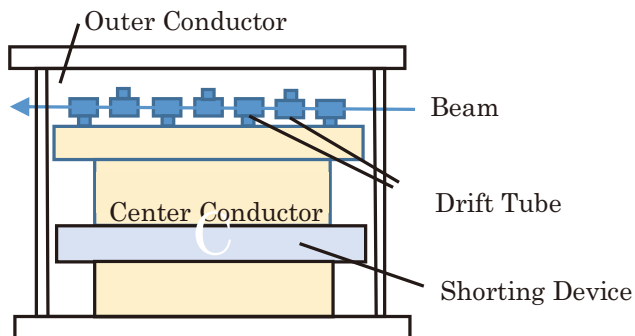
Fig. 1. Schematic diagram of cavity No. 5.

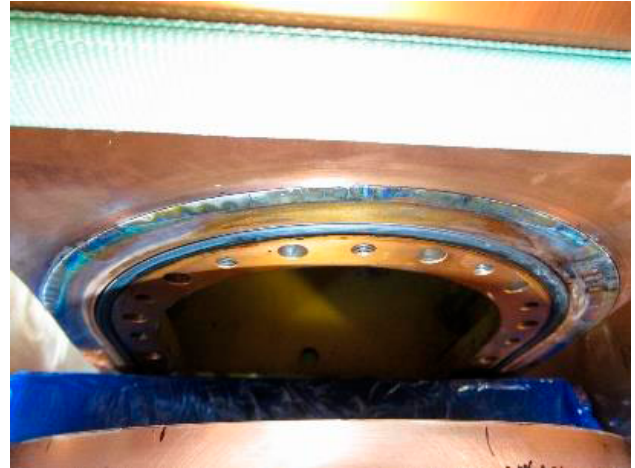
Fig. 2. Sealing face with a degenerate O-ring on center conductor of cavity No. 5.

trode was removed from the center conductor. A deteriorating O-ring across the ages was found as shown in Fig. 2 and the O-ring was replaced with new one. When the electrodes were assembled, thin silver plates were stacked on the joint area to place the electrodes on the level. The leak of the tank was fixed and the pressure of the tank was improved to 9×10^{-6} Pa.
