## Operation of the BigRIPS cryogenic plant

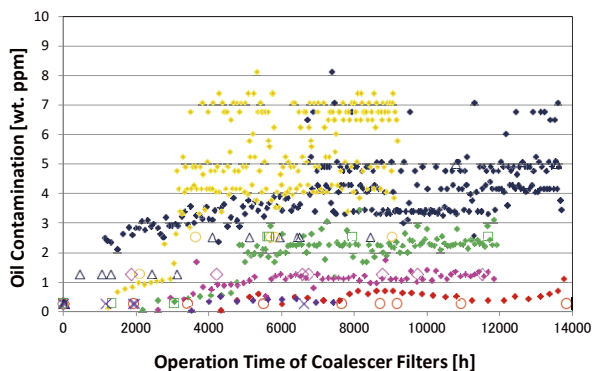
In addition to maintaining the mechanical components of the compressor unit, we replaced the activated charcoal and molecular sieves in the adsorbent vessel in August 2021. We measured the operation interval of the drain valves of the coalescer vessels in the compressor unit, to evaluate the oil contamination level. We replaced coalescer filter elements five times since 2008. The operation periods of replaced filter elements are from Aug. 2008 to July 2010, Sept. 2010 to July 2012, Sept. 2012 to July 2014, Sept. 2014 to July 2016, and Sept. 2016 to June 2019. Figure 1 shows an estimate of the oil contamination level at the entrance of the third coalescer vessel as a function of the coalescer filter operation time. The navy blue, green, and yellow diamonds represent the estimates for the first, the second, and the third elements, respectively. The fourth, the fifth and the sixth elements are shown with pink, red, and purple diamonds, respectively. The oil contamination values measured using the oil check kit are also shown. The open triangles, squares, and circles represent the results for the first, the second, and the third elements. The results for the fourth and the fifth elements are indicated by the open diamonds and circles, respectively. The cross represents the results of the sixth elements. Both estimations of the oil contamination level are consistent with each other, and the performance efficiency of the sixth filter element is apparently better than that of the others.

Fig. 1. Oil contamination at the entrance of the third coalescer vessel.

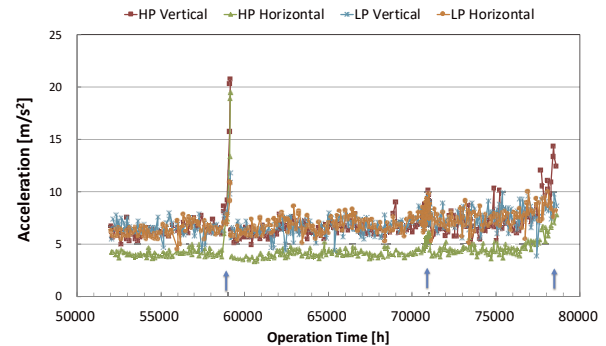
Fig. 2. Vibration acceleration of the compressor unit.

operation of the BigRIPS cryogenic plant after summer maintenance. This operation was terminated by an incident in the 2021 winter beam time. At 7:35 on December 3, the fire alarm of the RI-Beam Factory (RIBF) building rang, and the cryogenic plant operator found smoke emanating from the compressor unit of the BigRIPS cryogenic plant. After having made necessary emergency contacts, the plant operator stopped the compressor unit safely at 7:50. Evaporated helium gas from the STQ cryostats was transferred to the RIKEN liquid-helium supply and recovery system using a temporary recovery line. We inferred that the smoke was emitted from the coupling side bearing unit of the main motor of the compressor unit, since burnt grease was found around the coupling. A sudden increase in the operation current of the motor unit from 30.6 A to 33.6 A, which was measured at 7:28, also indicates a breakdown of the main motor.

We noticed an unusual noise produced by the main motor of the compressor unit since November 2021. We measured the vibrations of the compressor at the high-pressure and low-pressure sides since 2015. Figure 2 shows the vibration acceleration in the vertical and horizontal directions as a function of the total operation time. Continuous operation started with a total operation time of 77,683 h and the acceleration increased rapidly. The final measurement of the vibrations was performed on Dec. 1. Two additional rapid increases in the vibration acceleration at operation times of 59,000 h and 71,000 h were caused by damage to the bearing unit occurred in Dec. 2016<sup>1)</sup> and in June 2019.<sup>2)</sup>

The main motor unit was dismantled from the compressor unit and shipped to the manufacturer's factory for repairs in January 2022. The origin of the unusual vibrations is under investigation.
